**REMOVAL PROGRAM  
AFTER ACTION REPORT  
FOR THE  
PARSONS PAPER MILL SITE  
HOLYOKE, HAMPDEN COUNTY, MASSACHUSETTS  
16 NOVEMBER 2009 THROUGH 26 APRIL 2010**

Weston Solutions, Inc.  
Superfund Technical Assessment and Response Team III (START)  
3 Riverside Drive  
Andover, Massachusetts 01810

August 2010

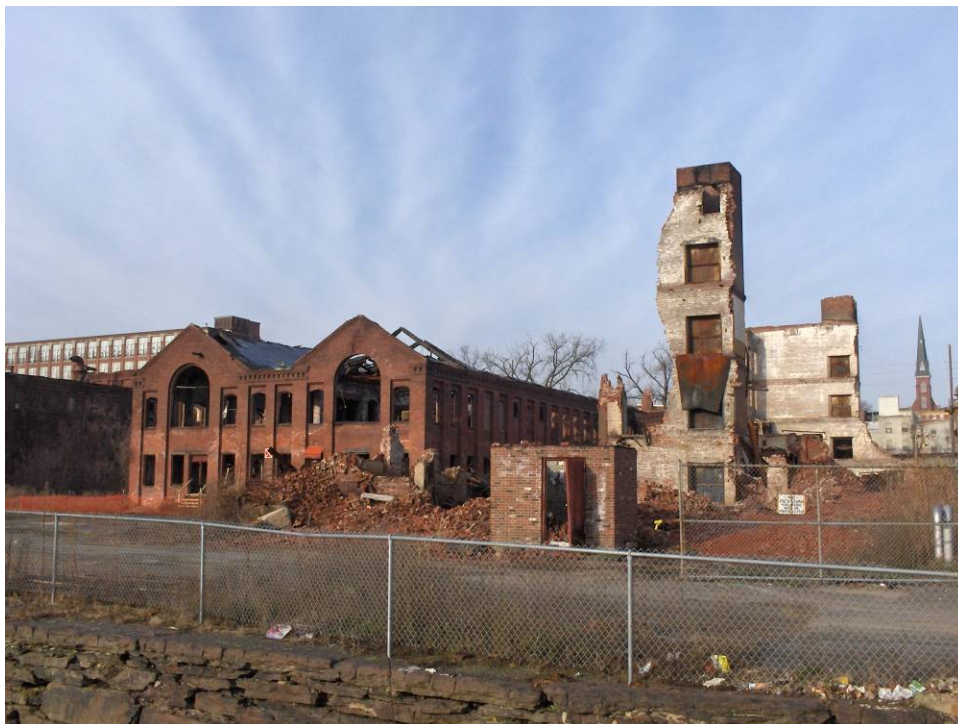
**SCENE:** View of Building Nos. 3 and 4 following the June 2008 fire. Photograph taken facing northwest.

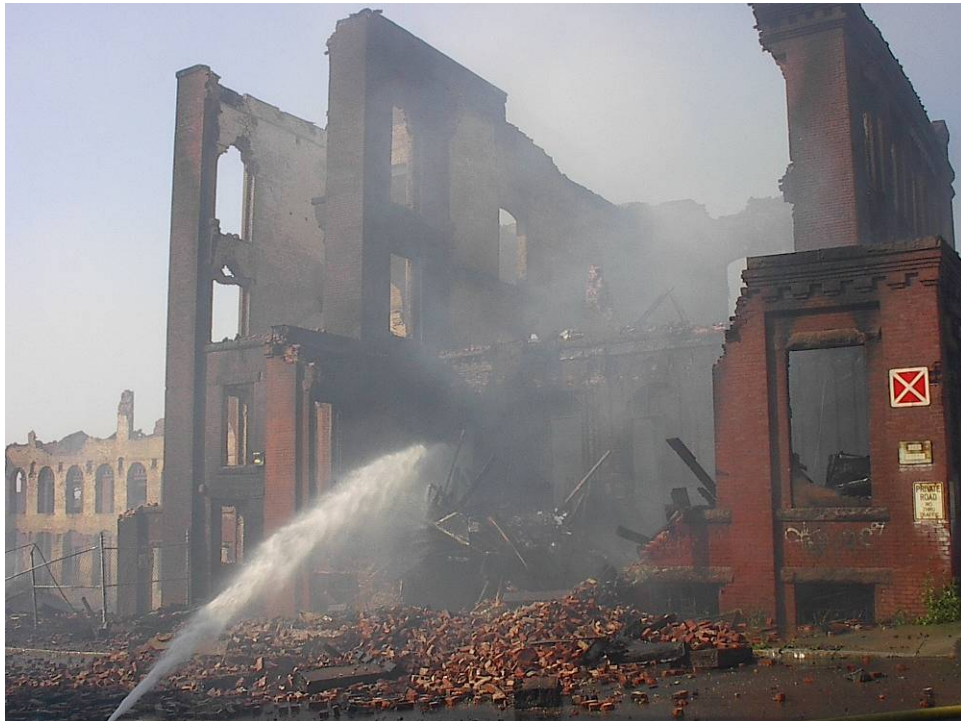
**SCENE:** View of Building No. 4 immediately following the fire. Photograph taken facing west.

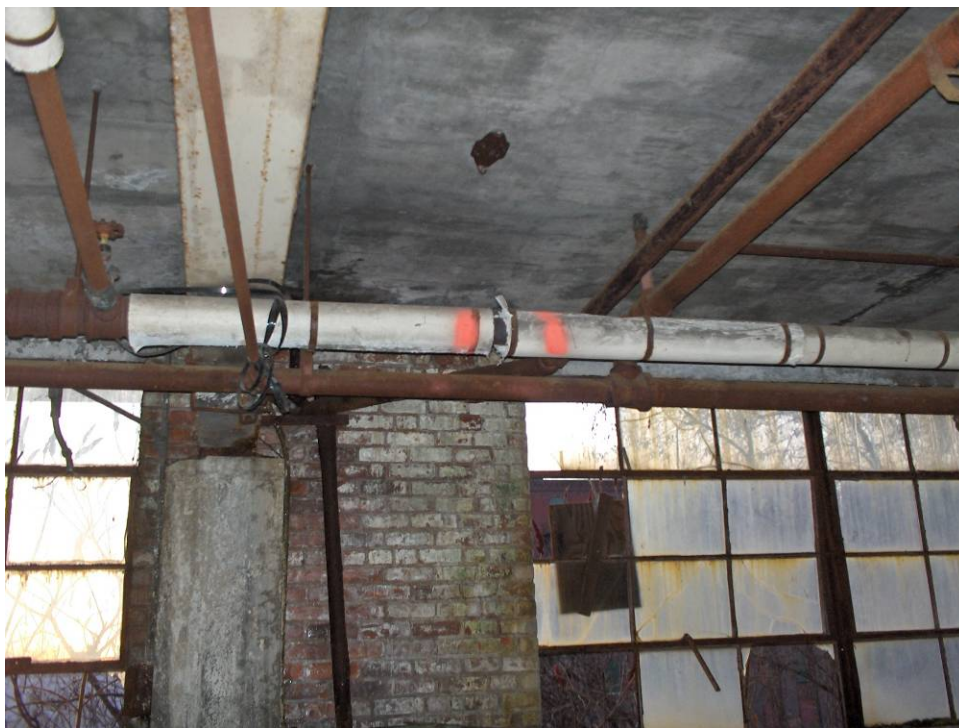
**SCENE:** View of the asbestos-containing material (ACM) sample, ACM-54, from pipe insulation on the first floor of Building No. 1.

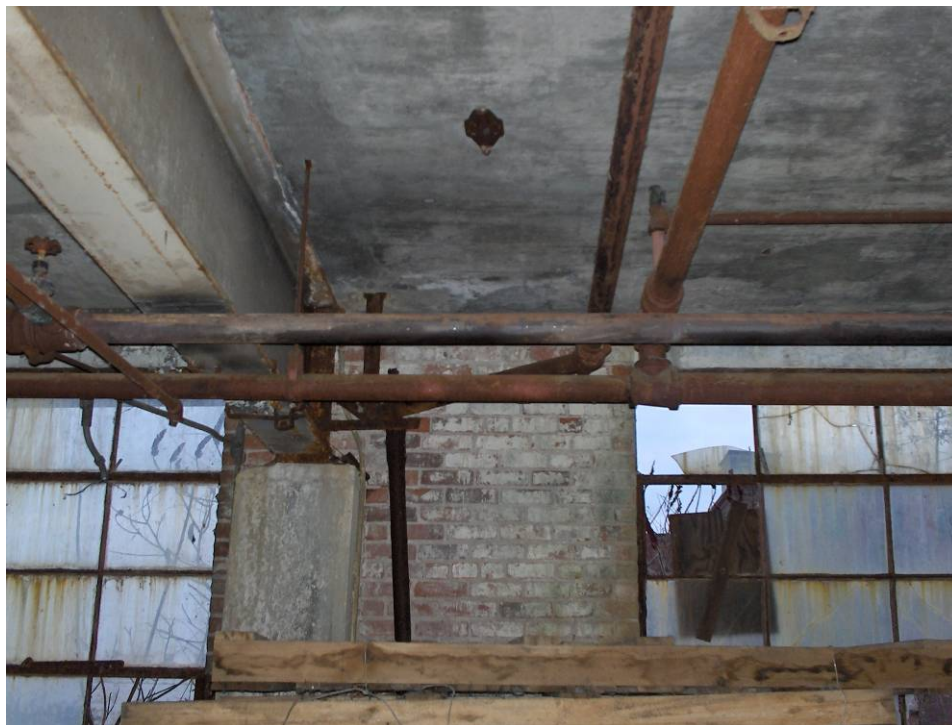
**SCENE:** View of the pipes following asbestos removal in the area where ACM-54 was previously located.

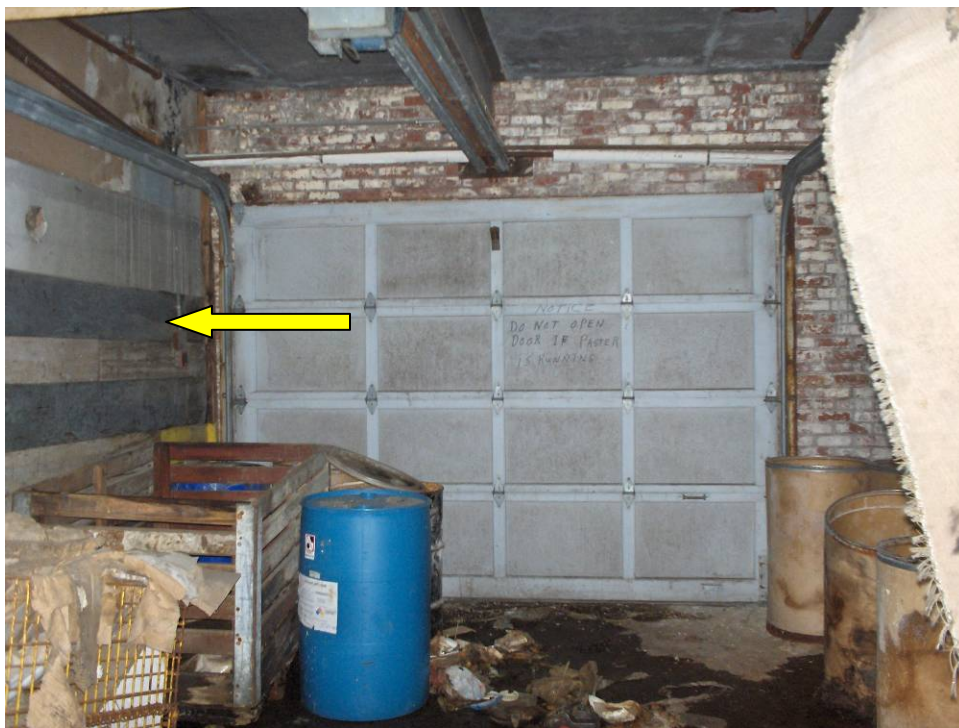
**SCENE:** View of the garage on the first floor of Building No. 1, with transite wall panels.

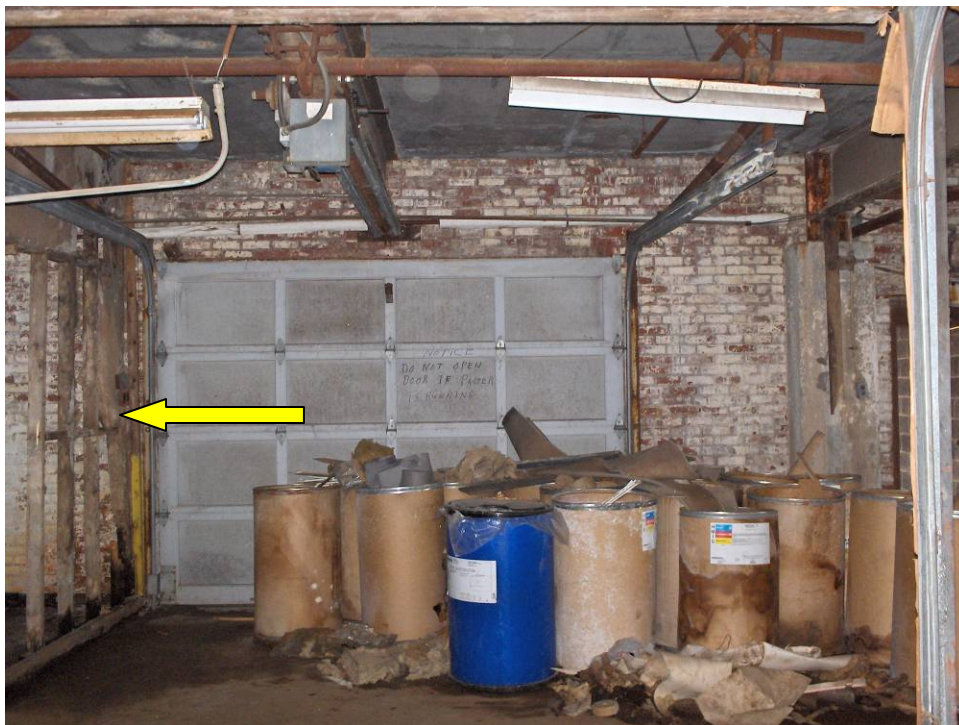
**SCENE:** View of the garage on the first floor of Building No. 1, with all the transite wall panels removed.

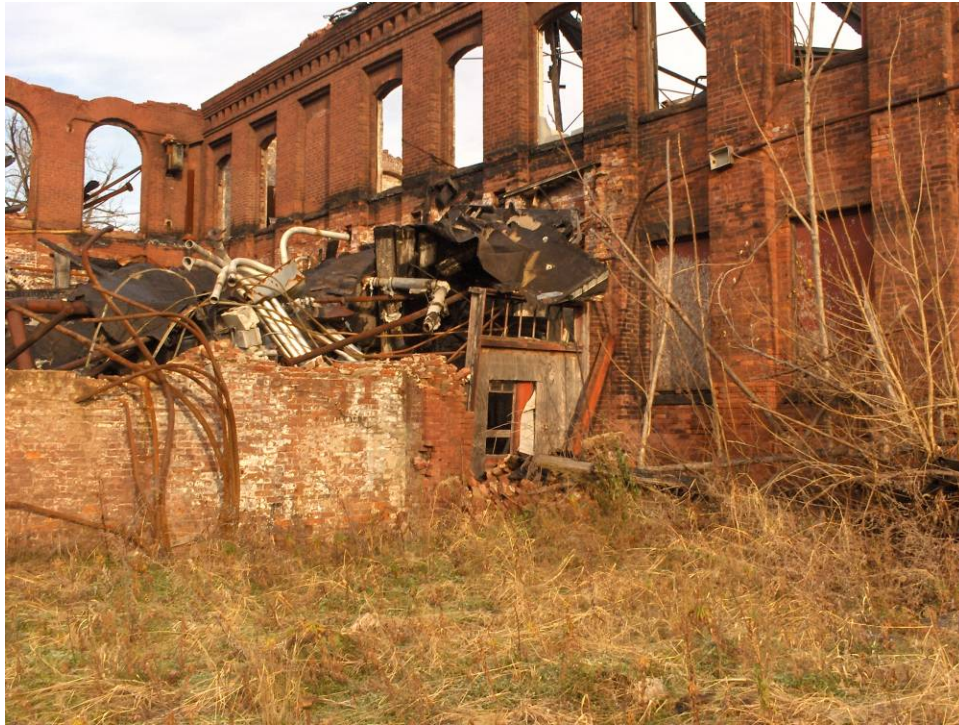
**SCENE:** View of the boiler room (abutting Building No. 3) prior to debris removal. Photograph taken facing north.

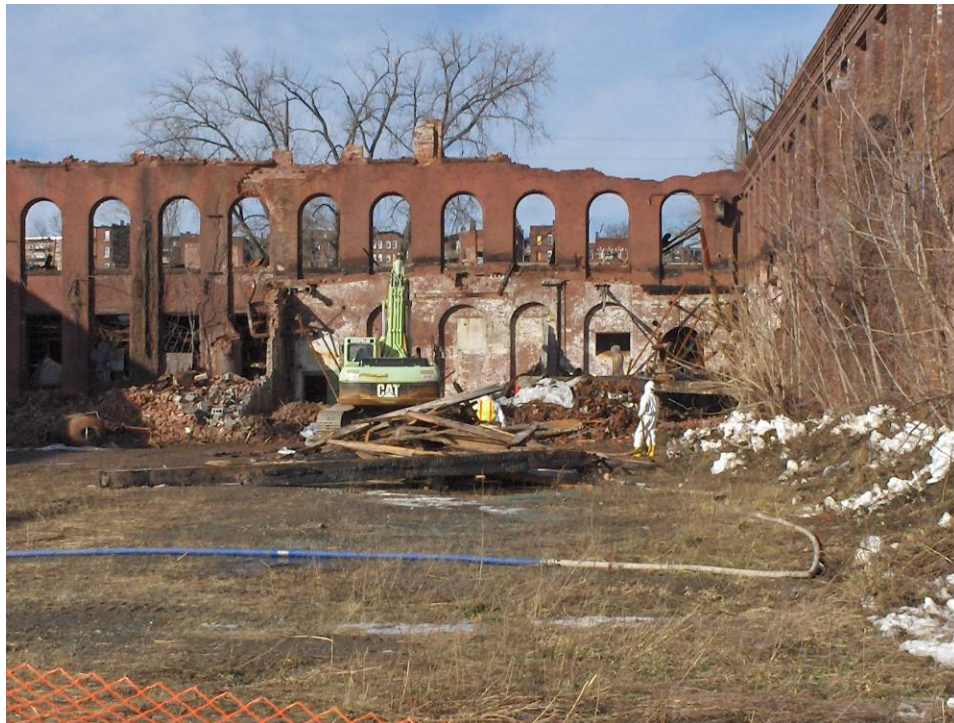
**SCENE:** View of debris and ACM removal from the boiler room. Photograph taken facing northwest.

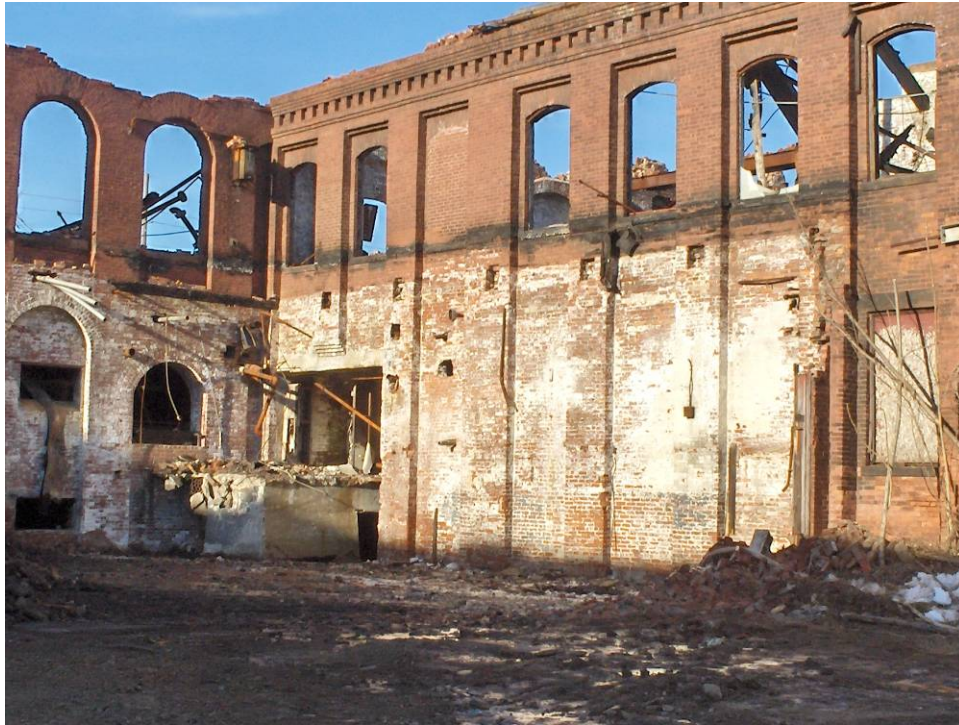
**SCENE:** View of the boiler room area following debris and ACM removal. Photograph taken facing north.

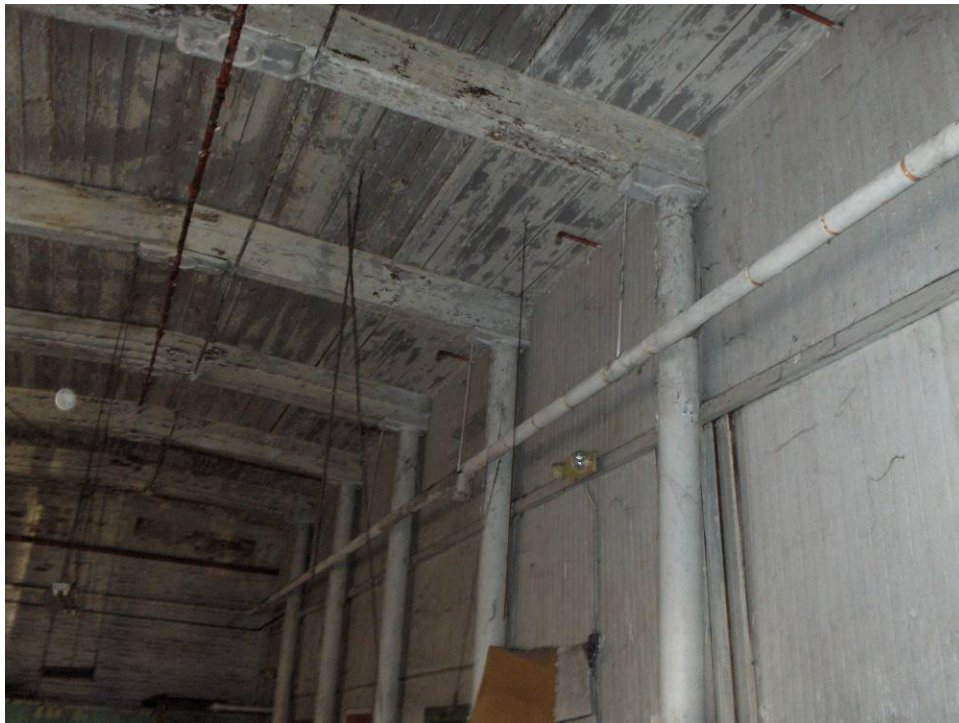
**SCENE:** View of the pipe insulation on the third floor of Building No. 2 prior to removal.

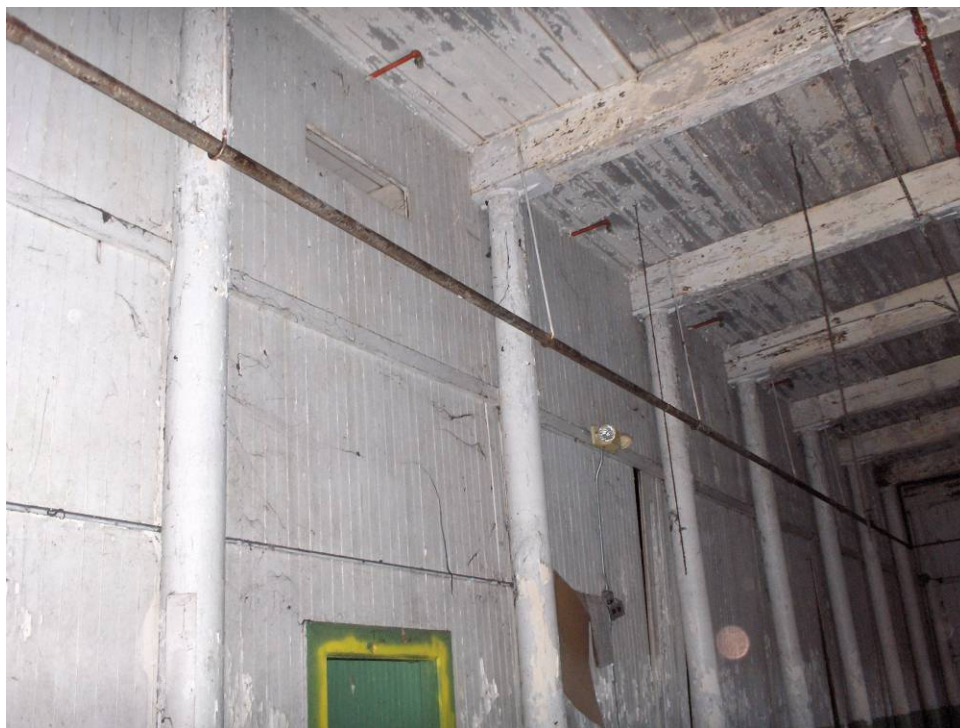
**SCENE:** View of the horizontal pipes on the third floor of Building No. 2 following asbestos removal.

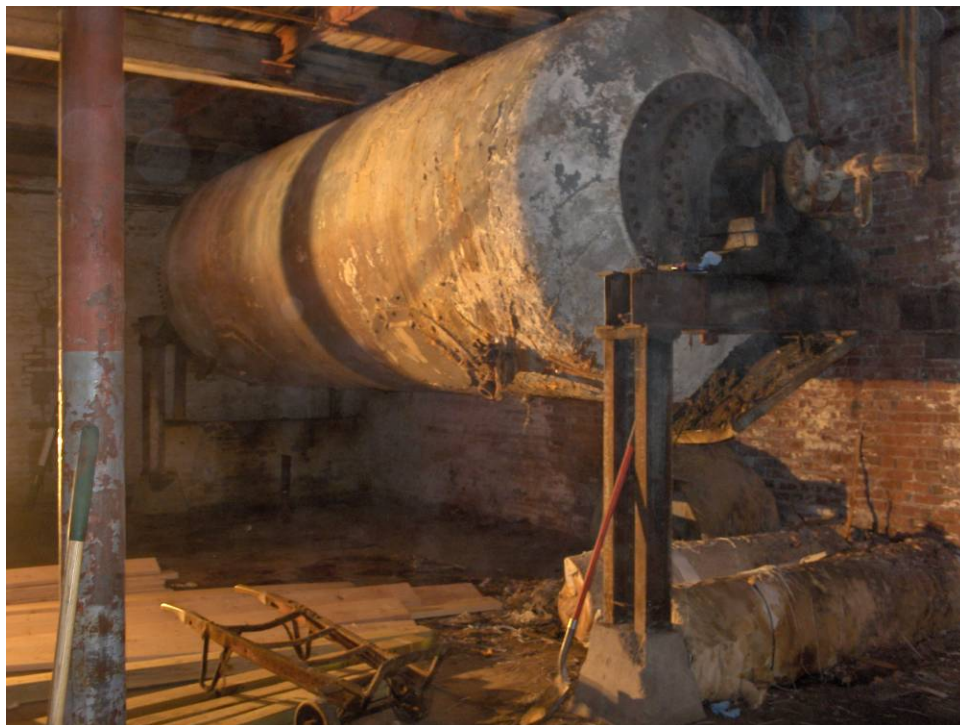
**SCENE:** View of the fabric bleaching tank turned and cleared of all loose debris underneath it. Bulk asbestos sample ACM-53 was collected from this tank.

- Conducting perimeter air sampling.
- Removing asbestos from the fabric bleaching tank on the second floor of Building No. 2.
- Removing scrap metal from around and within the old foundation of Building No. 4 and stockpiling it between Building Nos. 2 and 3.
- Constructing entranceways to the basement of Building No. 2.

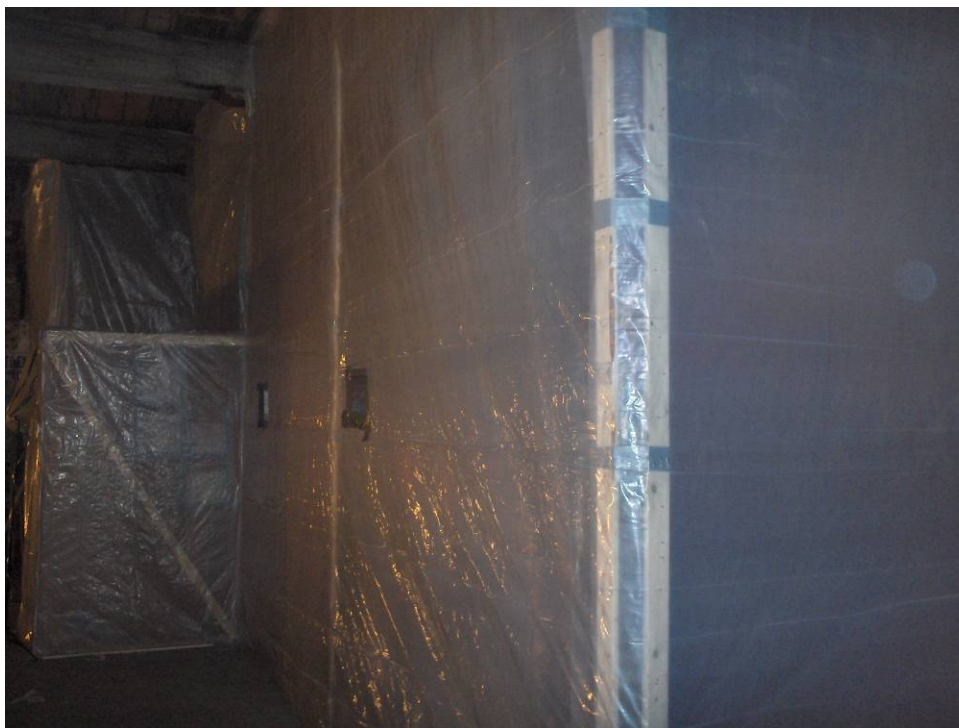
**SCENE:** View of the containment unit built around the bleaching tank prior to ACM removal.

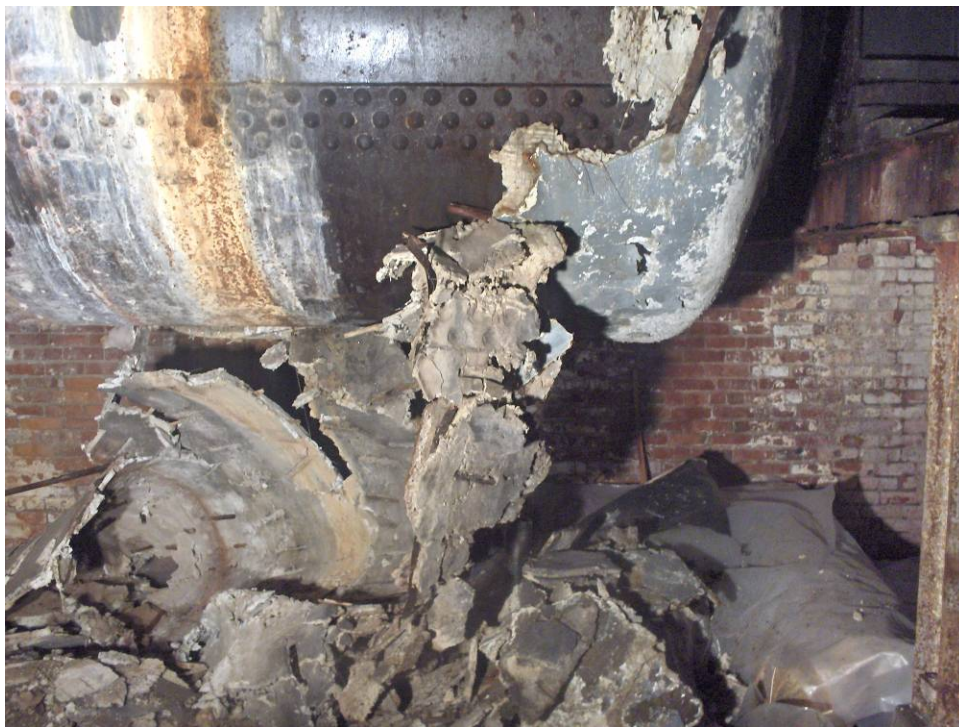
**SCENE:** View of ACM removed from the bleaching tank.

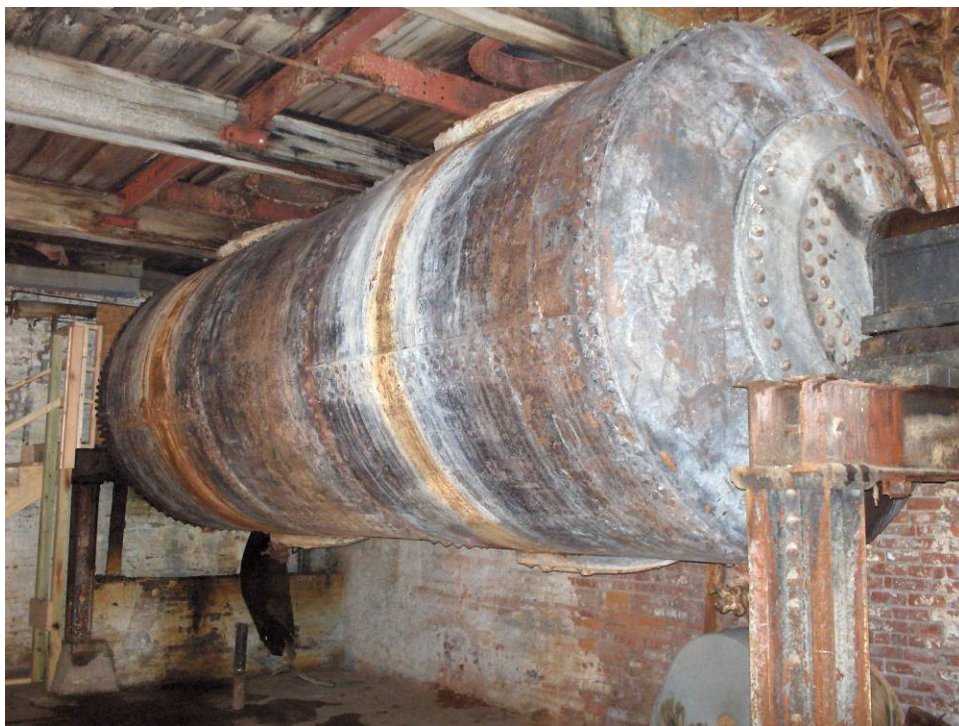
**SCENE:** View of the bleaching tank with ACM removed and with the area decontaminated and the containment unit removed.

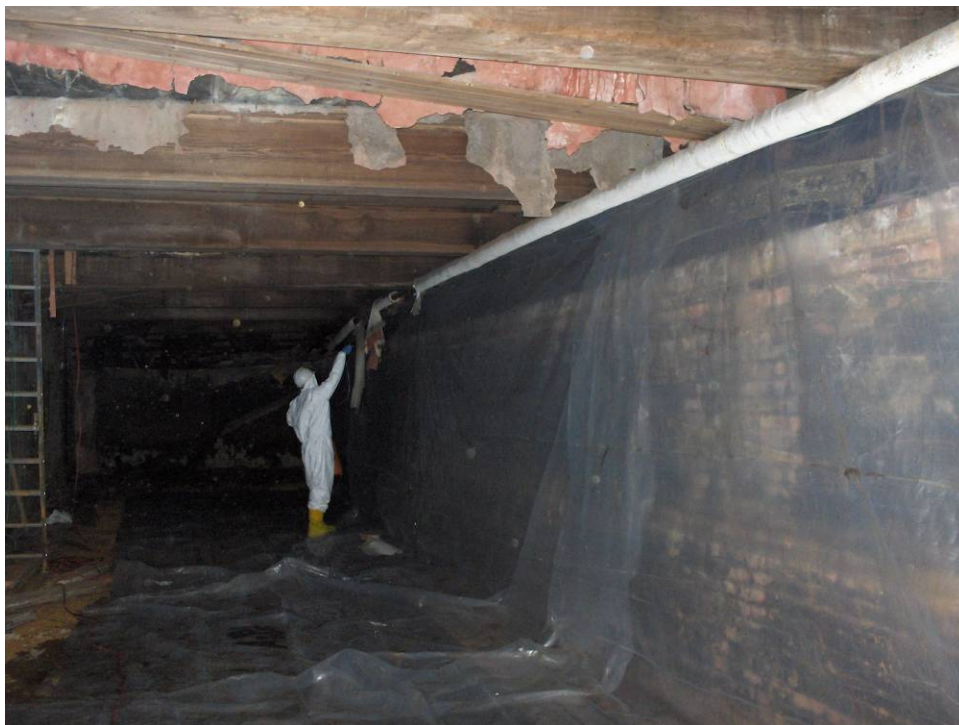
**SCENE:** View of preparation for ACM removal in the basement of Building No. 2.

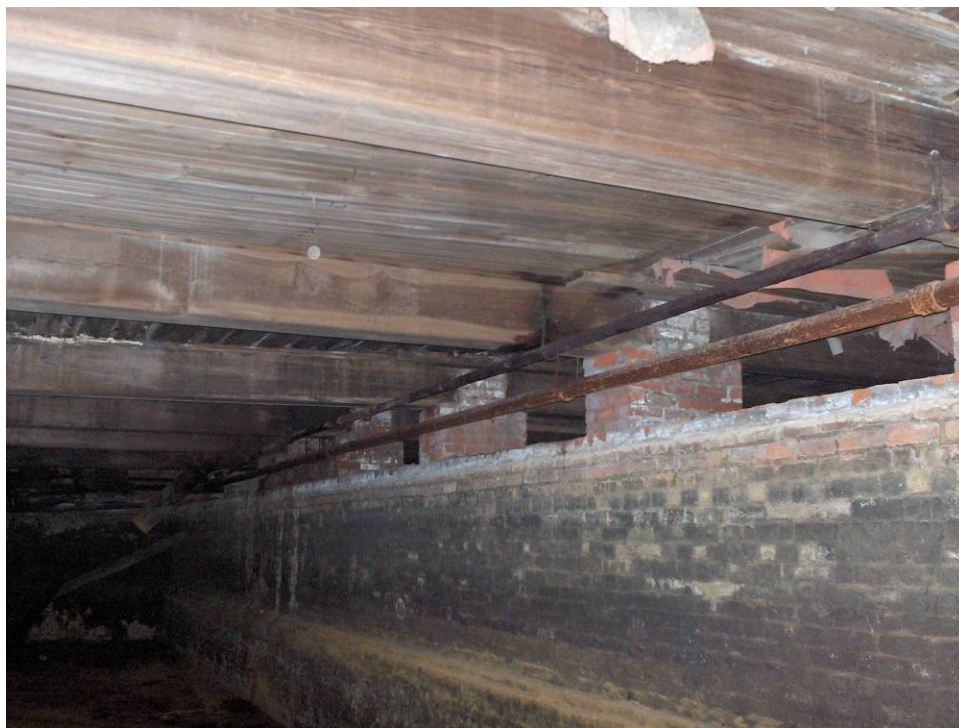
**SCENE:** View of the pipes in the basement of Building No. 2 following ACM removal.

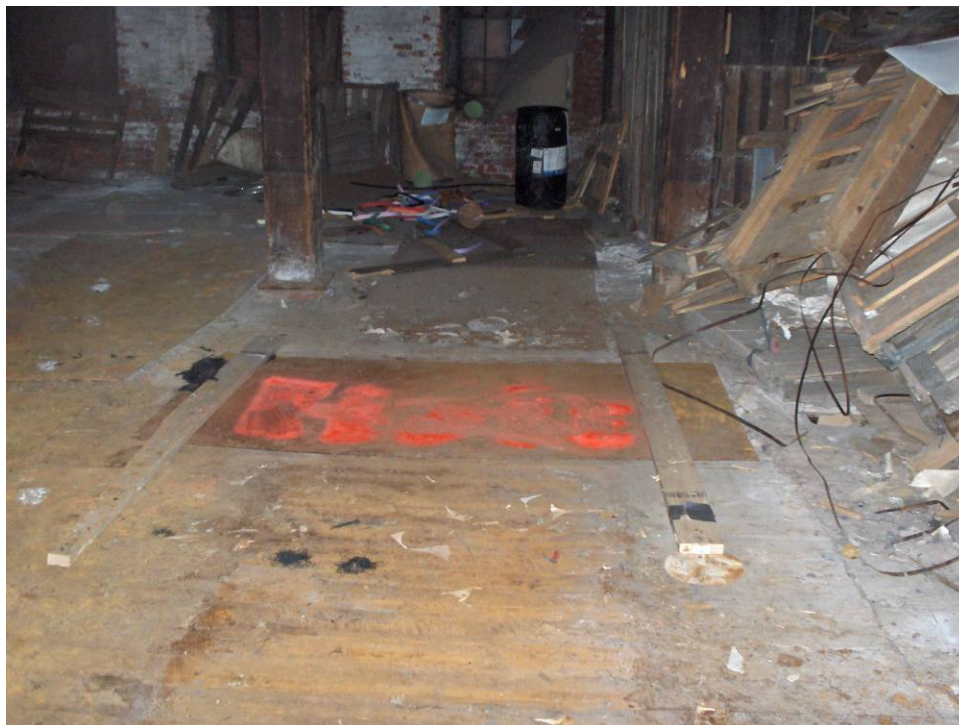
**SCENE:** View of the sealed-off Confined Space Entrance 1 on the first floor of Building No. 2, following ACM removal in that section of the basement.

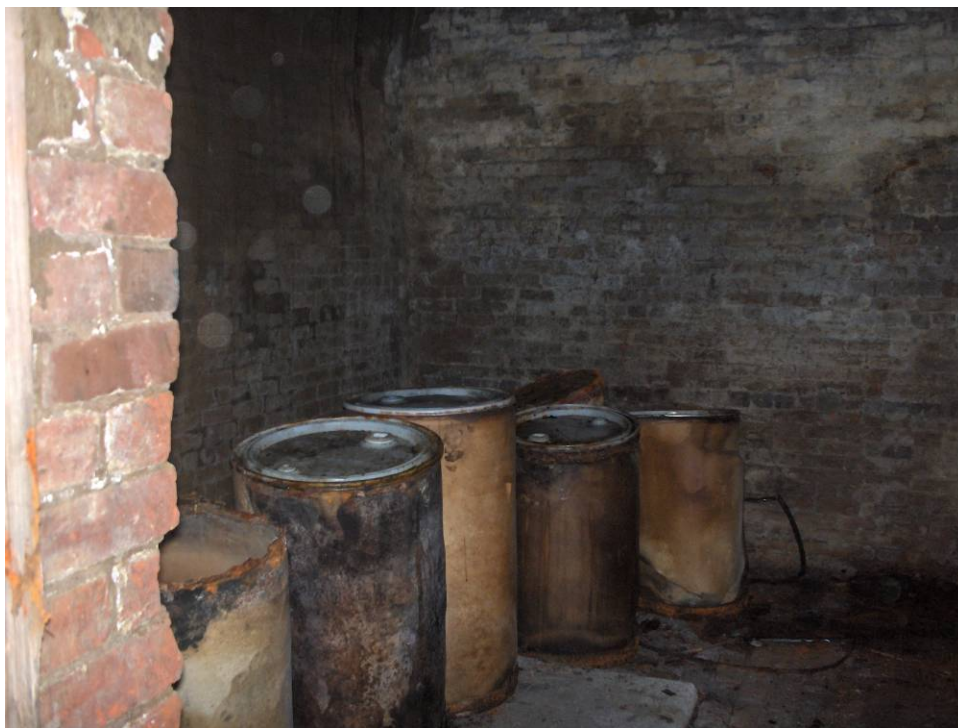
**SCENE:** View of the fiber drums filled with ACM that were located in a holding chest in the basement of Building No. 3.

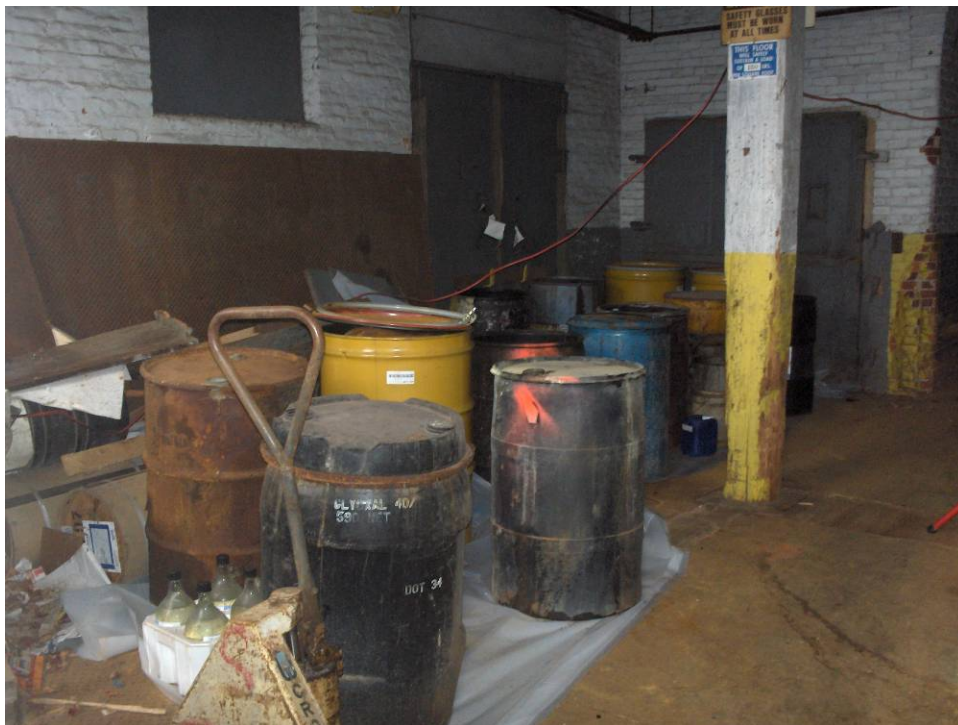
**SCENE:** View of containers on site that were collected, Hazard Categorized (HazCatted), consolidated, overpacked, and then disposed of off site.

- Conducting perimeter air sampling.
- Loading asbestos-containing debris from Building Nos. 4 and 5 for off-site disposal.
- Removing asbestos from the floor and pipes in the basement of Building No. 3.
- Staging drums with unknown contents.
- Performing Hazard Categorization (HazCat) tests on 18 unknown drums.

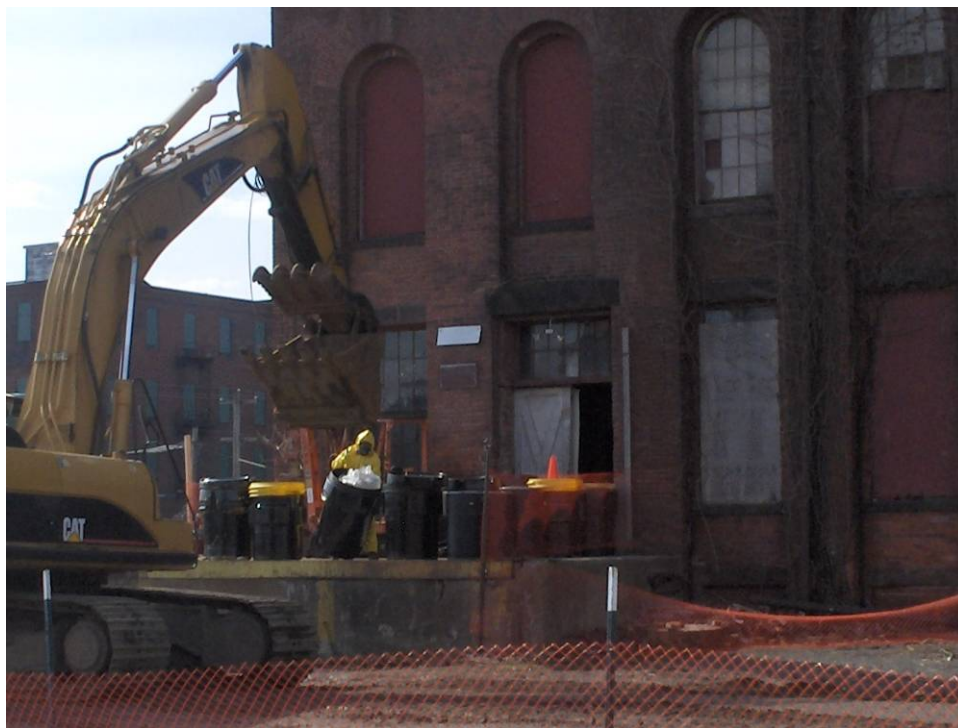
**SCENE:** View of the overpacking of a container of sulfuric acid to be disposed of off-site. Photograph taken facing south.

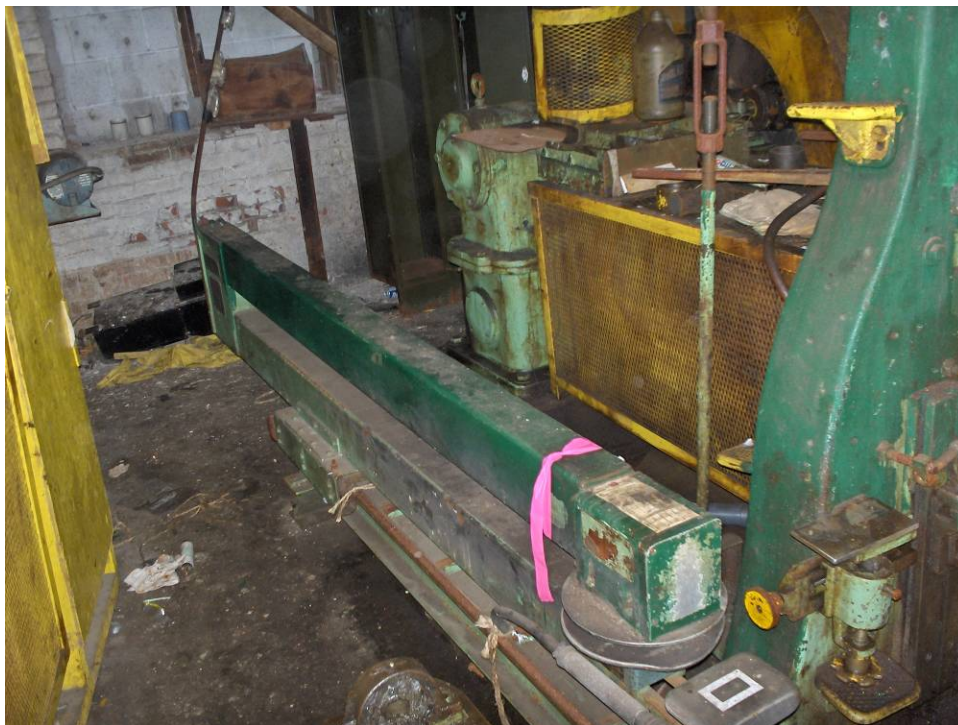
**SCENE:** View of one of the two Krypton-85 (KR-85) radiation sources located on site.

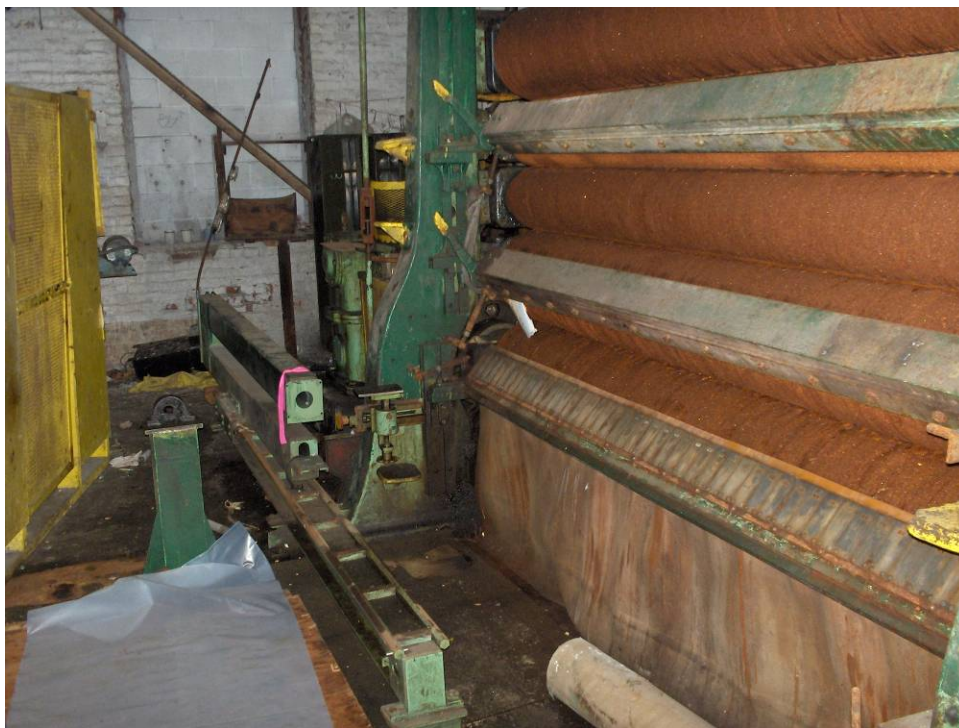
**SCENE:** View of the radiation source removed from the second floor of Building No. 1.

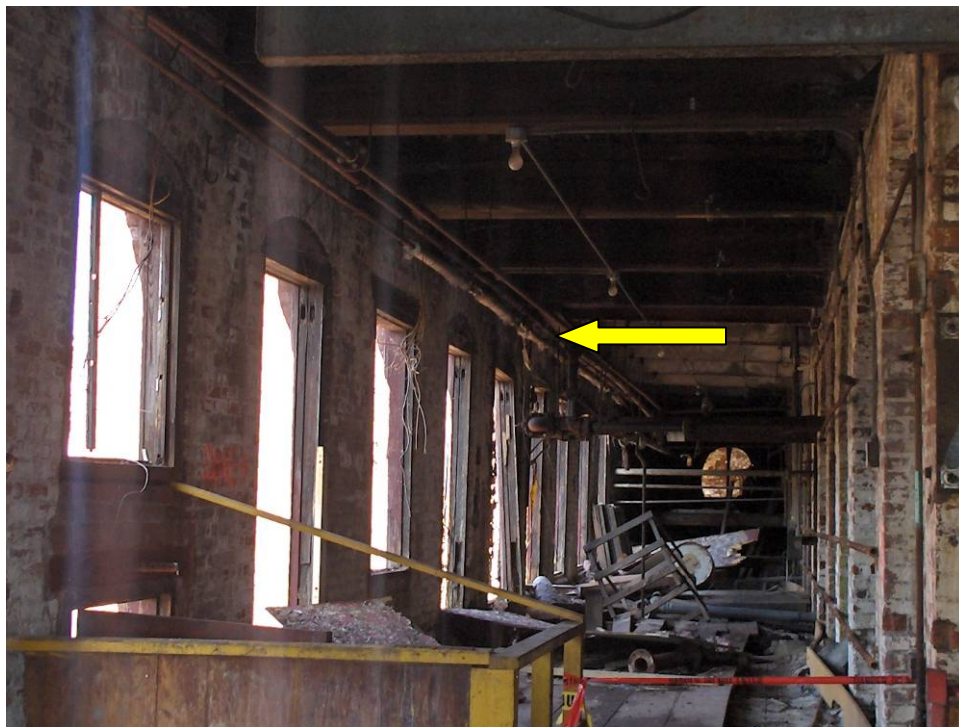
**SCENE:** View of the ACM pipe insulation on the first floor of the west section of Building No. 3 prior to removal.

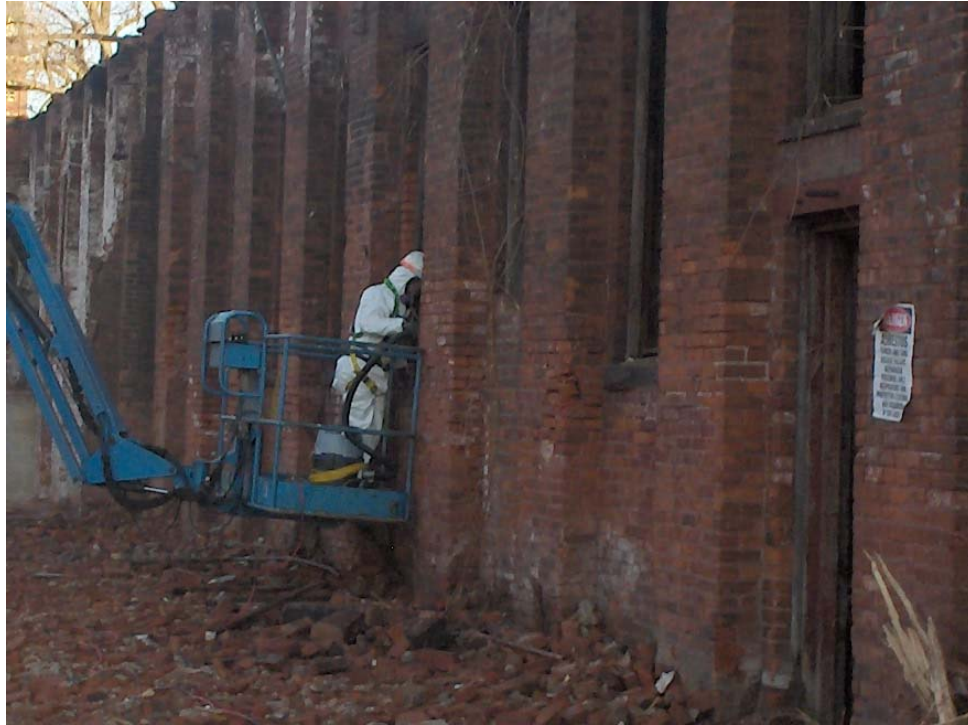
**SCENE:** View of High Efficiency Particulate Air (HEPA) vacuuming of the window sills after the pipe insulation removal beneath the first floor pipes of Building No. 3. The windows were the point of entry for the ACM removal since the floor was unsafe. Photograph taken facing north.

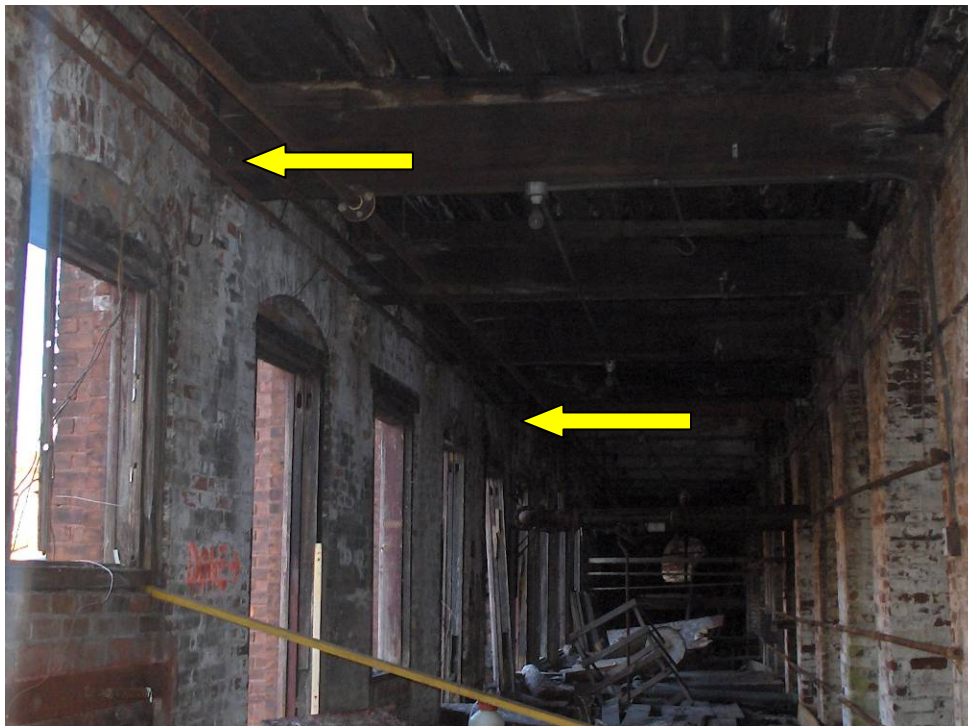
**SCENE:** View of the pipes on the first floor of the west section of Building No. 3 following ACM removal.

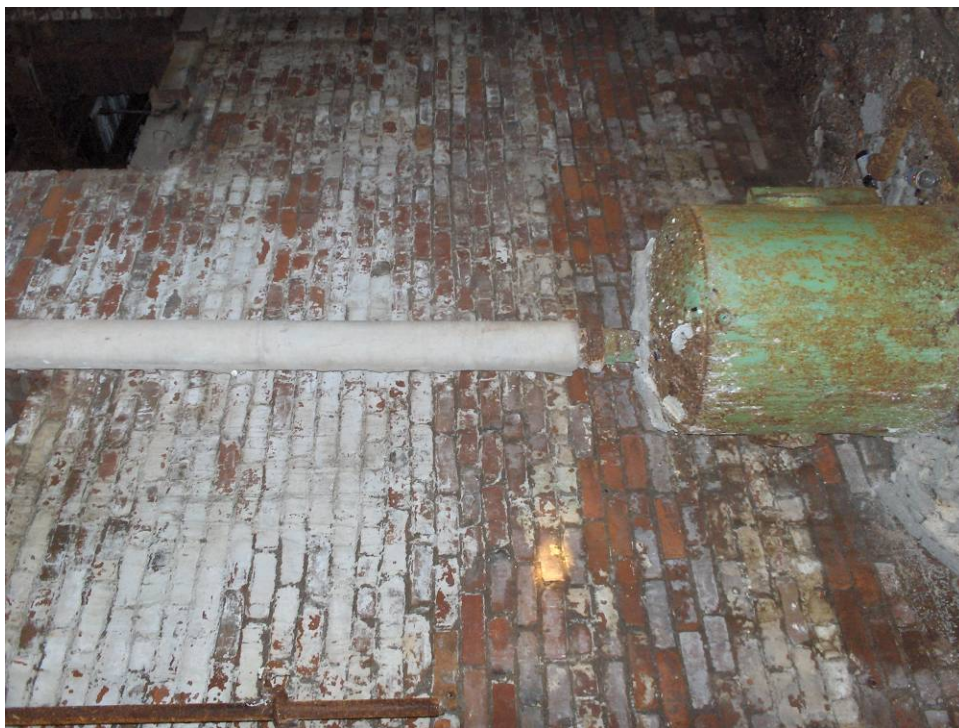
**SCENE:** View of a boiler with ACM pipe insulation in the basement of the southwest section of Building No. 3.

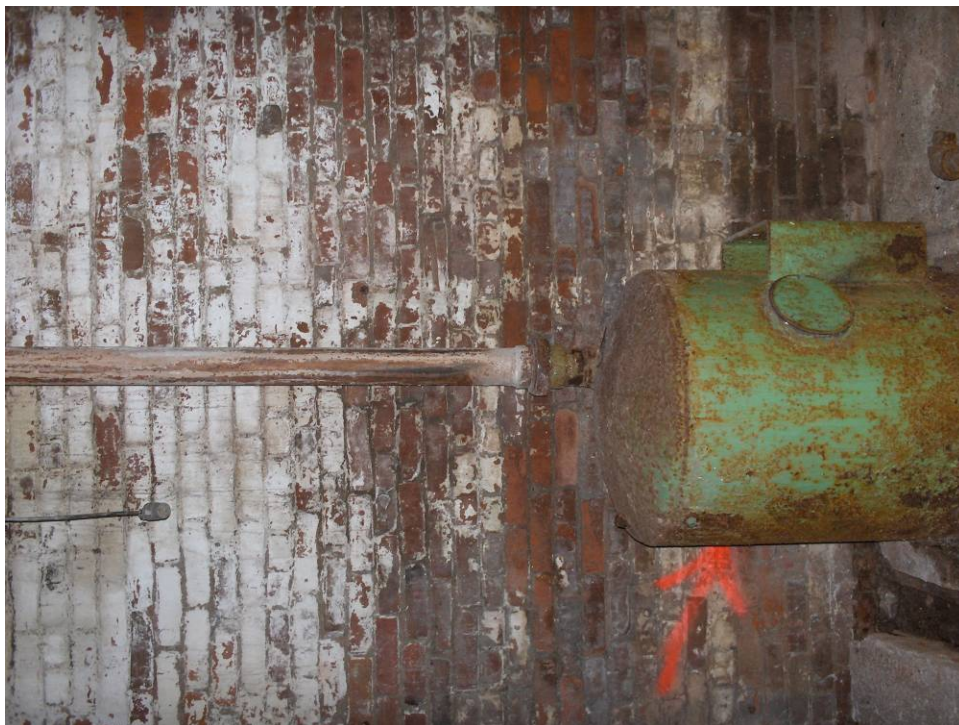
**SCENE:** View of a boiler in the basement of the southwest section of Building No. 3 following ACM removal.

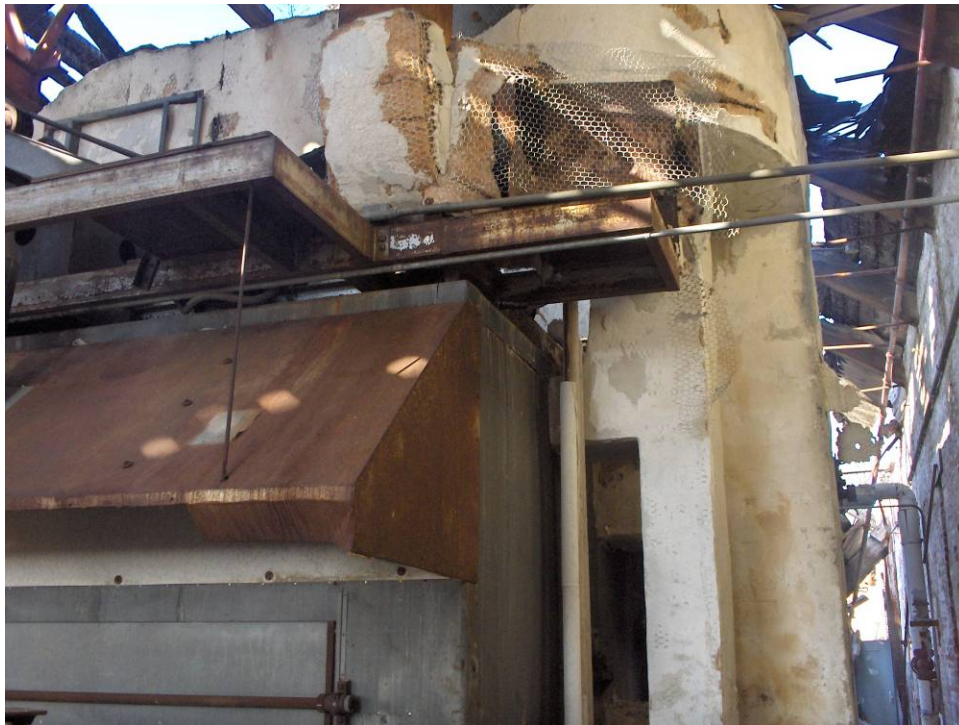
**SCENE:** View of the ACM-covered dryer unit on the second floor of Building No. 3 prior to any demolition work or ACM removal.

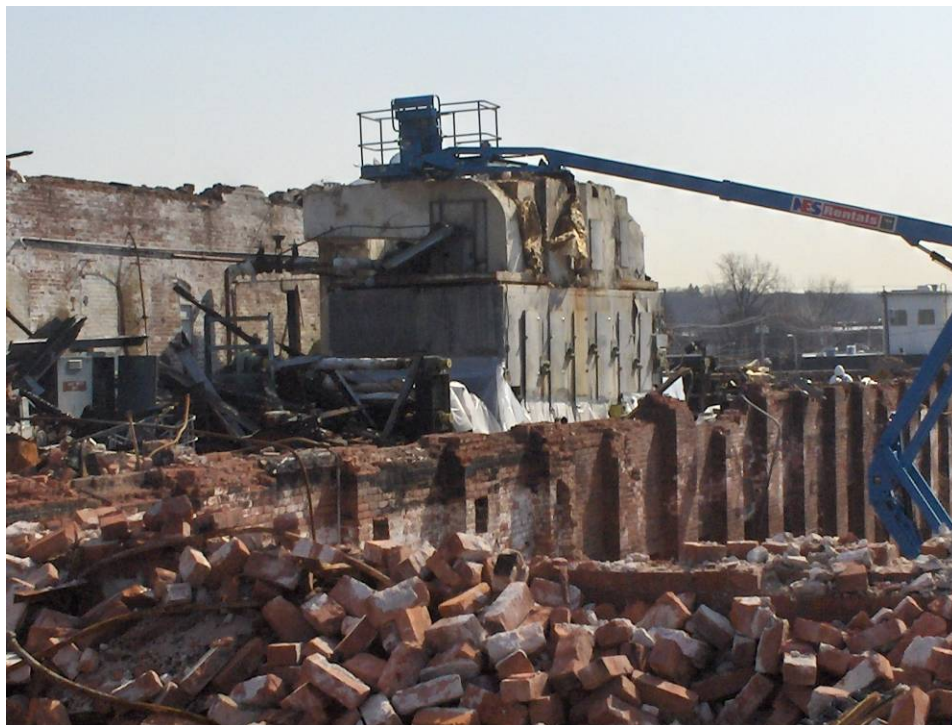
**SCENE:** View of the dryer unit on the second floor of Building No. 3 during ACM removal following the demolition. Photograph taken facing east.

- Conducting perimeter air sampling.
- Removing all loose debris from the second floor of Building No. 3 that resulted from the demolition work.
- Removing asbestos from the first floor of Building No. 3.
- Preparing and staging the second floor of Building No. 3 for asbestos removal from the dryer unit.
- Removing asbestos from the dryer unit on the second floor of Building No. 3.

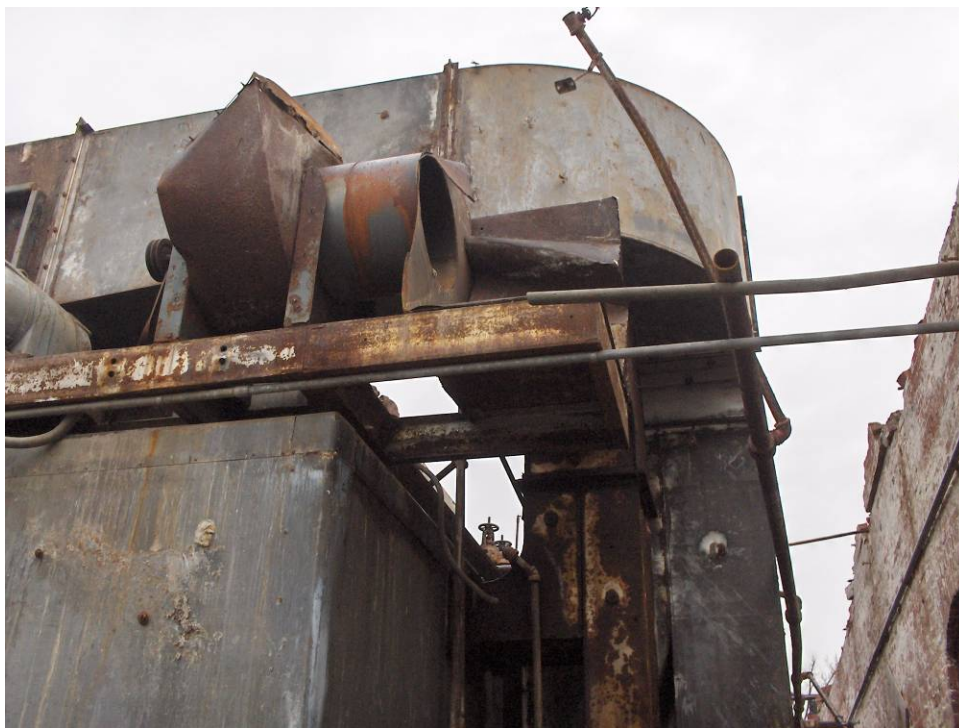
**SCENE:** View of the dryer unit following ACM removal. Photograph taken facing northwest.
